CONTINUING ELIGIBILITY INSPECTION (CEI) REPORT
FOR FLOOD CONTROL PROJECTS

1. Project Name: Kahawainui Stream Flood Control Project

2. Date of Inspection: January 7, 2003

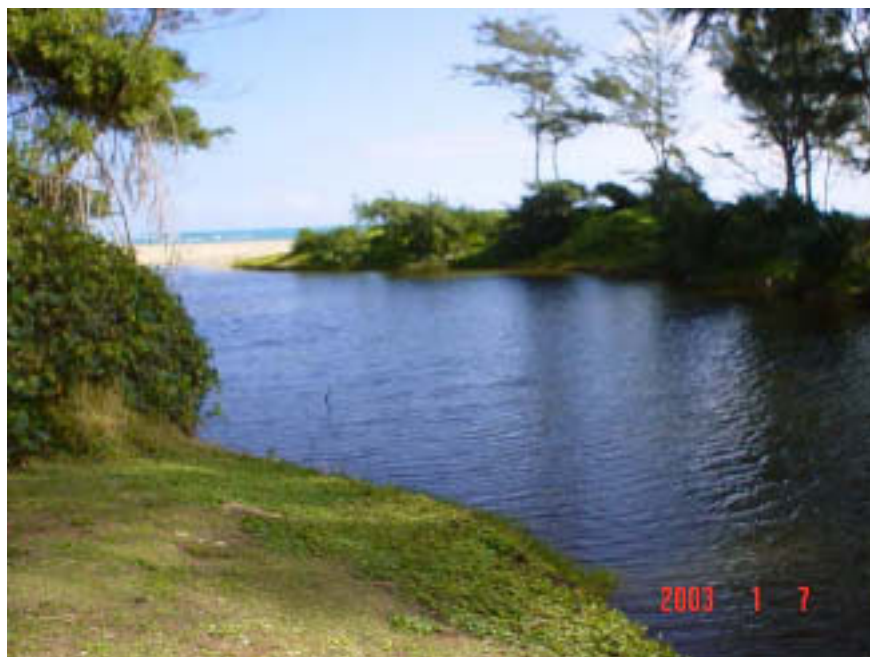
a. Channel Sta. 14+00, Overview looking at mouth of stream.

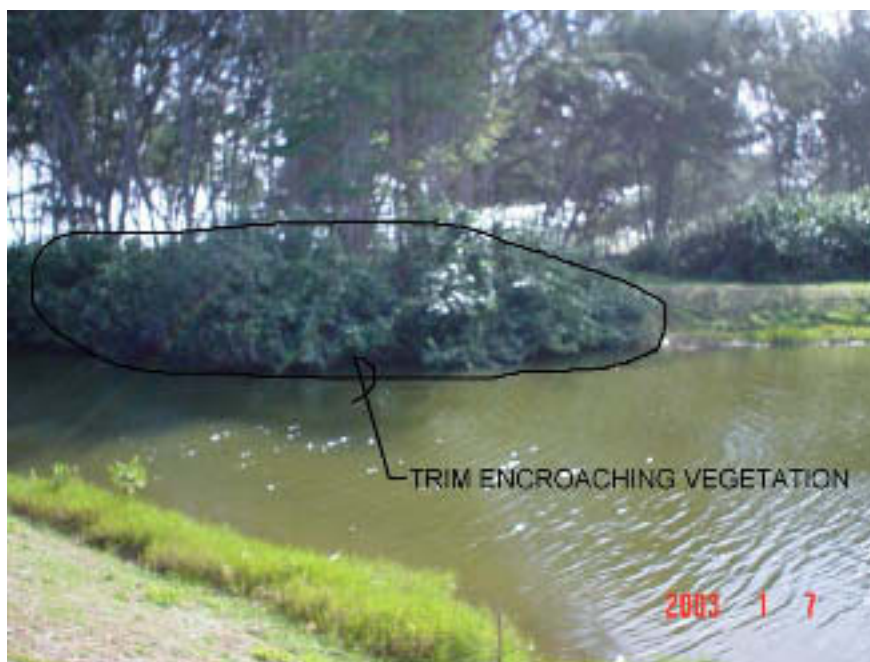
b1. Channel Sta. 14+50, RB, Trim encroaching vegetation.

| Location | Station | Defects |
|---|---|--|
| Channel, RB | 14+50 | Trim branch encroachments. |

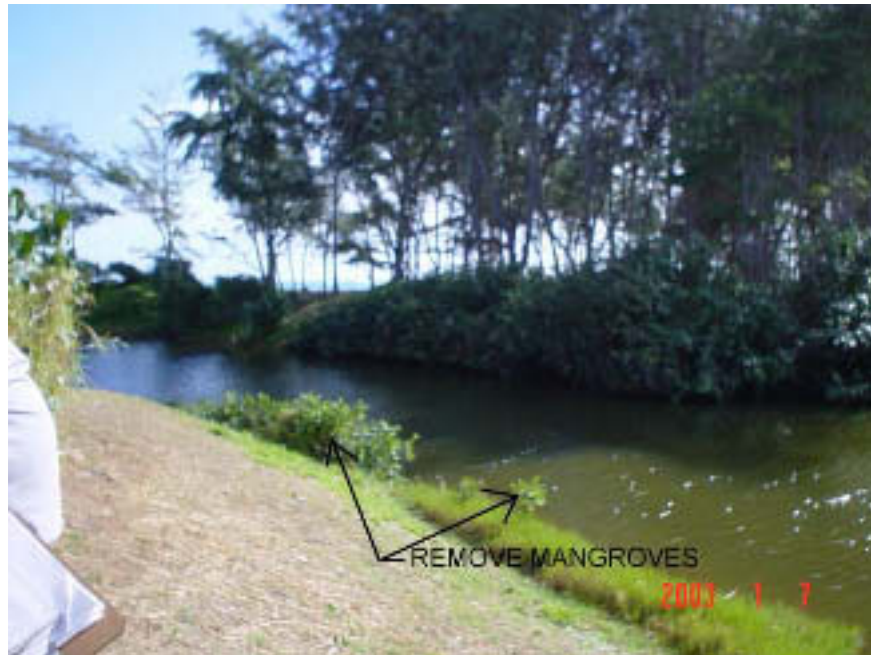
b2. Channel Sta. 14+50, LB, Remove mangroves.

| Location | Station | Defects |
|---|---|--|
| Channel, LB | 14+50 | Remove mangroves. |

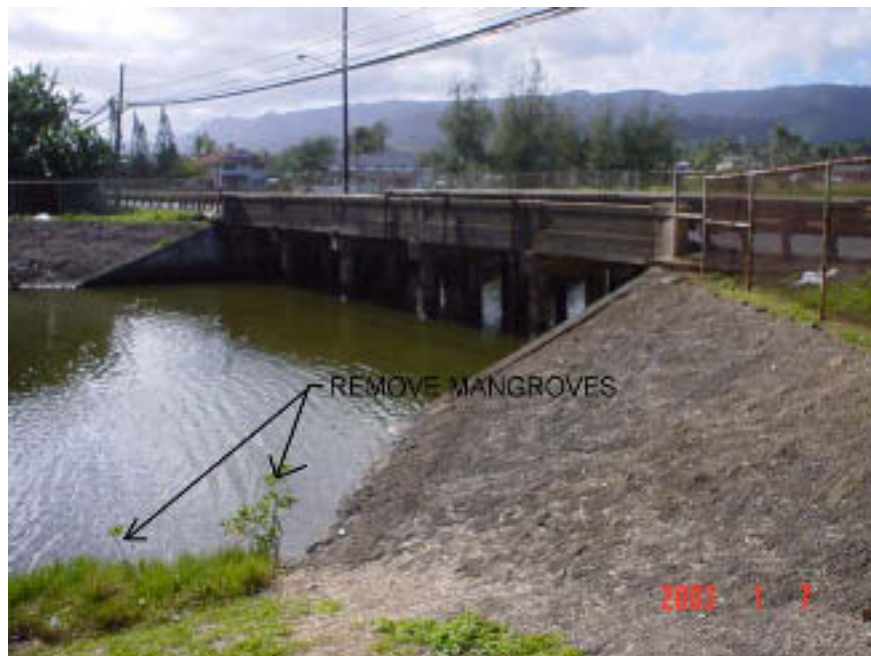
c. Channel Sta. 15+80, LB, Remove mangroves. Overview looking mauka at Kamehameha Highway.

| Location | Station | Defects |
|---|---|--|
| Channel, LB | 15+80 | Remove mangroves. |

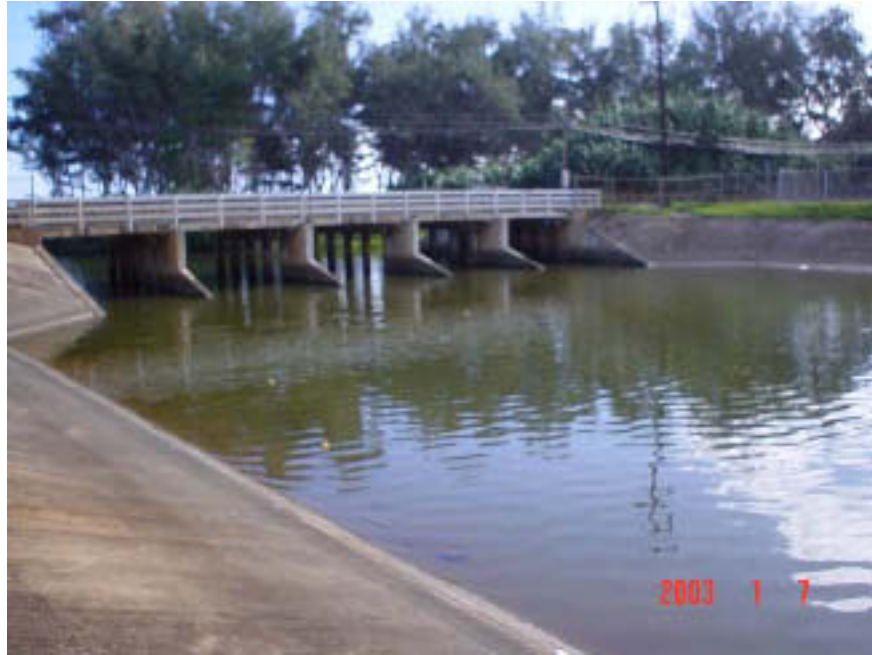
d. Channel Sta. 16+00, Overview looking makai at Kamehameha Highway.

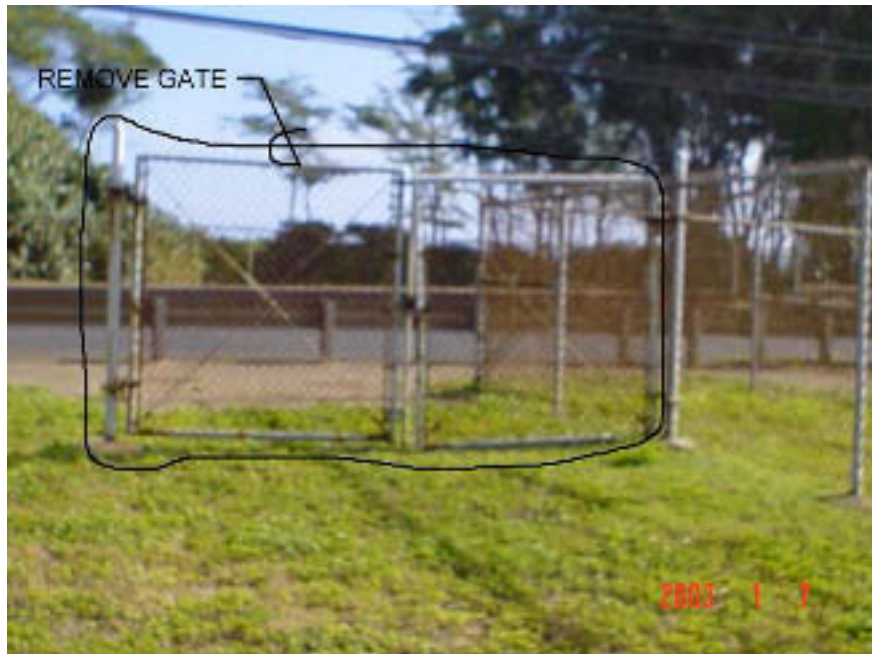
e. Channel Sta. 16+50, LB, Remove gate, which does not serve any purpose, from fence.

| Location | Station | Defects |
|---|---|--|
| Channel, LB | 16+50 | Remove gate from fence. |

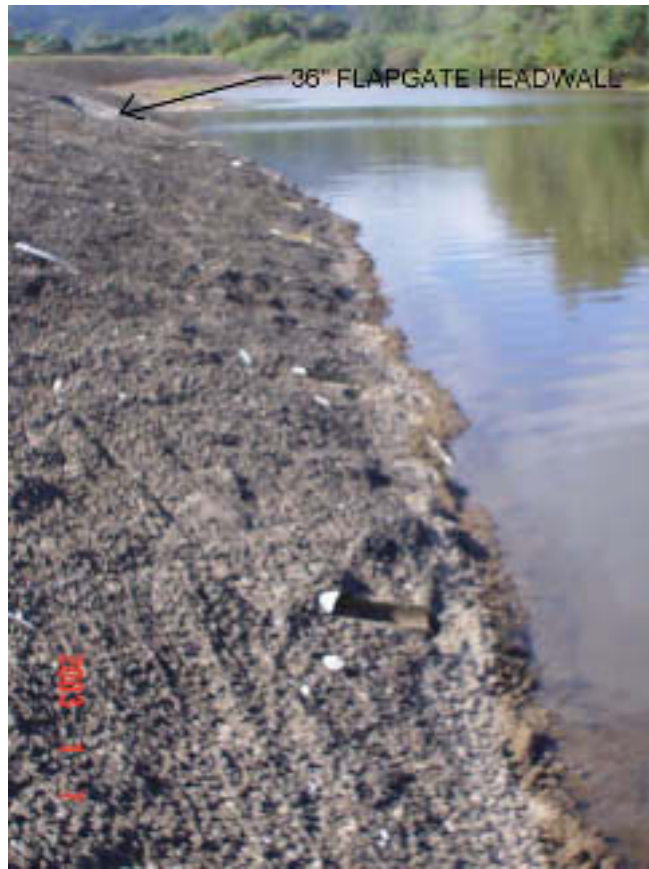
f1. Channel Sta. 19+50, RB, Overview.

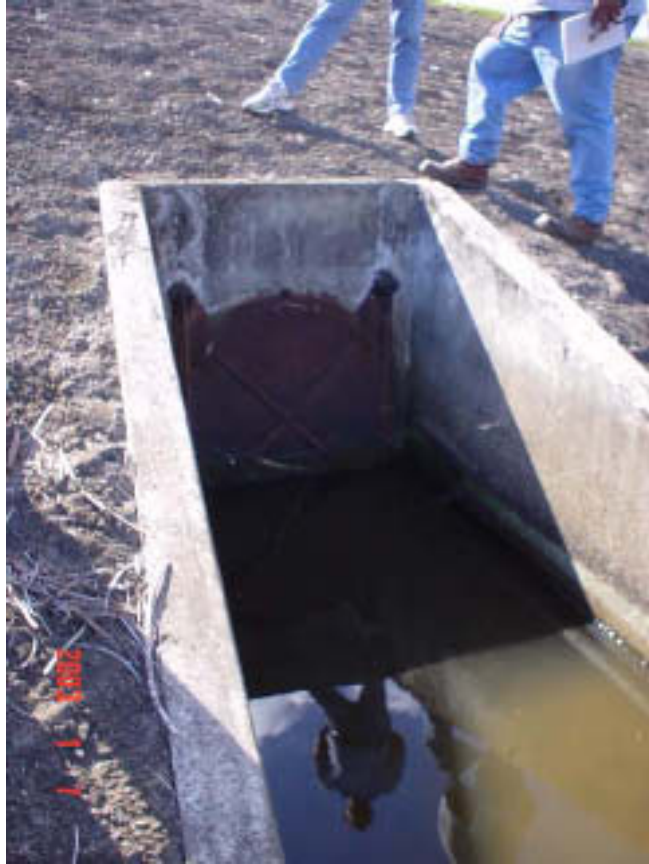
f2. Channel Sta. 19+50, RB, Flapgate overview. Clear debris from obstructing flapgate.

| Location | Station | Defects |
|---|---|--|
| Channel, RB | 19+50 | Remove debris from obstructing flapgate and patch concrete adjacent top of headwall. |

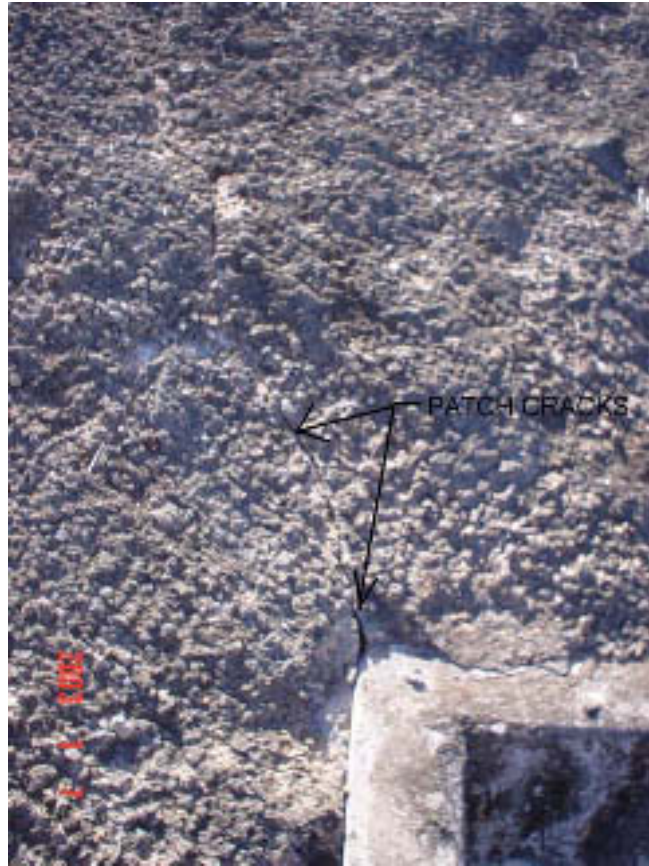
f3. Channel Sta. 19+50, RB, Patch cracks adjacent top of headwall.

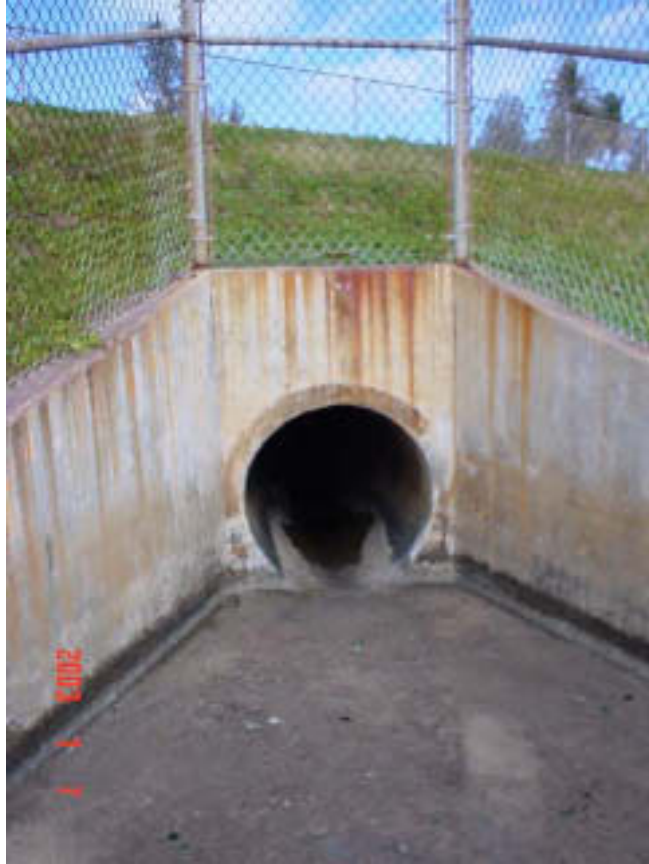
f4. Channel Sta. 19+50, RB, Overview of interior drainage to flapgate headwall.

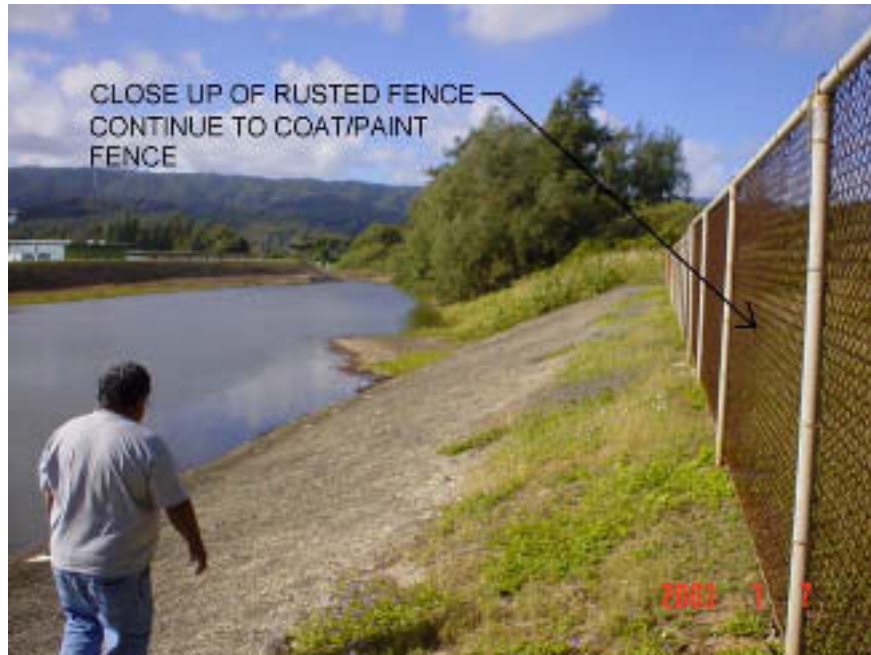
g1. Channel Sta. 20+00, LB, Continue to coat/paint fence to protect from continued oxidation. The last two hundred feet of fence (Sta. 19+50 to 21+50) needs to be replaced because the fabric has been rusted out.

| Location | Station | Defects |
|---|---|--|
| Channel, LB | 20+00 | Continue to coat/paint entire portion of fence to protect from oxidation. Replace 200' corroded fence fabric at mauka end. |

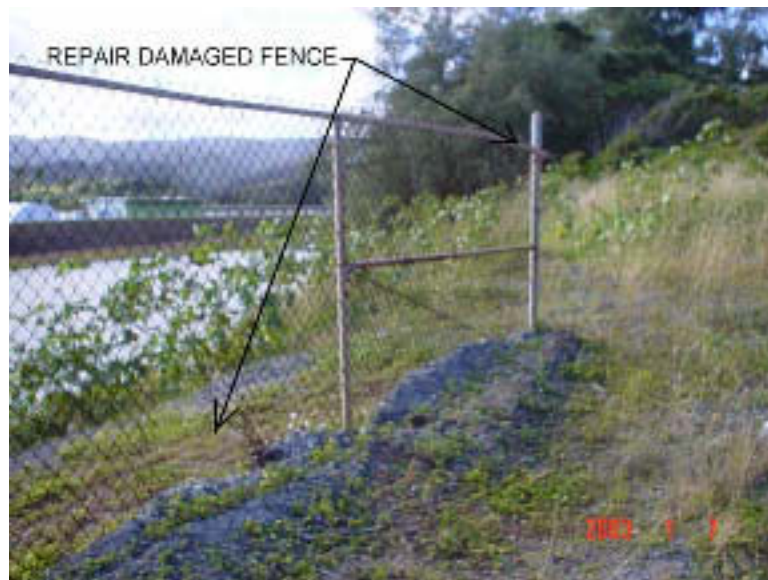
g2. Channel Sta. 21+50, LB, Repair damaged fence; to be replaced.

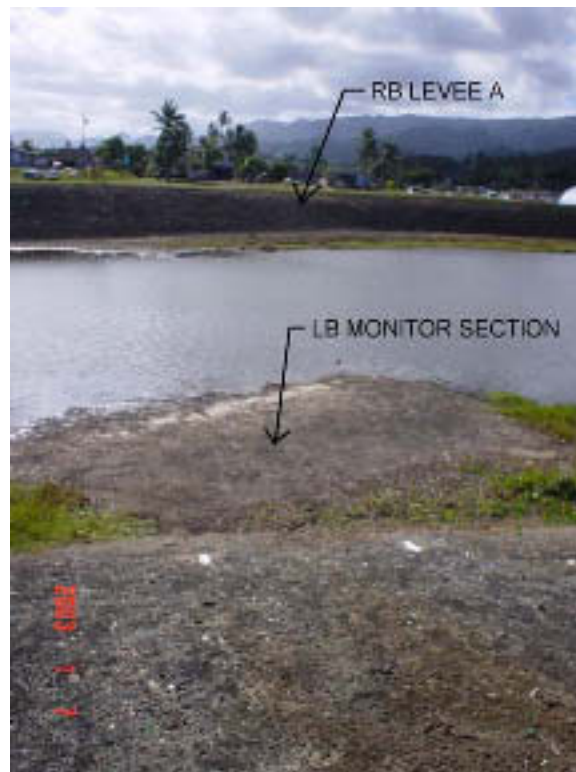
h. Levee A Sta. 0+50, Overview of levee A on RB. Monitor LB concrete section in the future for upstream soil sediments.

| Location | Station | Defects |
|---|---|--|
| Opposite Levee A, LB | 0+50 | Monitor concrete invert for future accretion of soil sediments. |

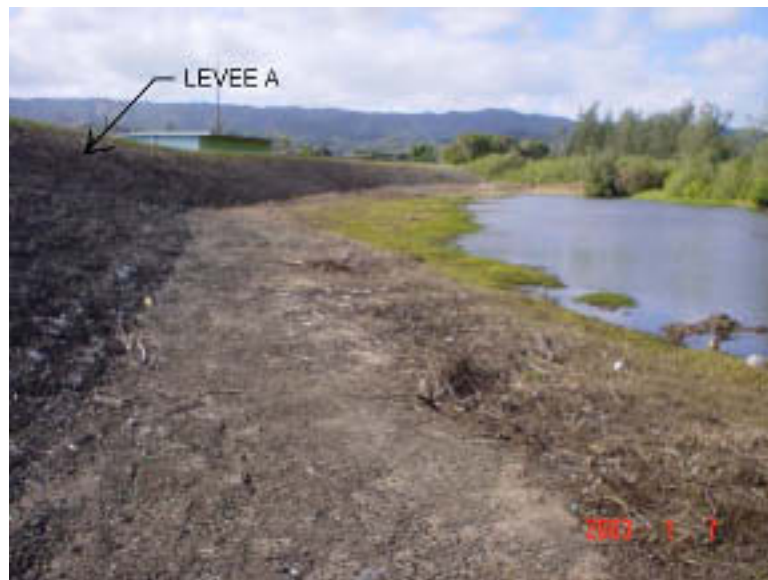
i. Levee A Sta. 3+00, RB, Overview of levee A looking mauka.

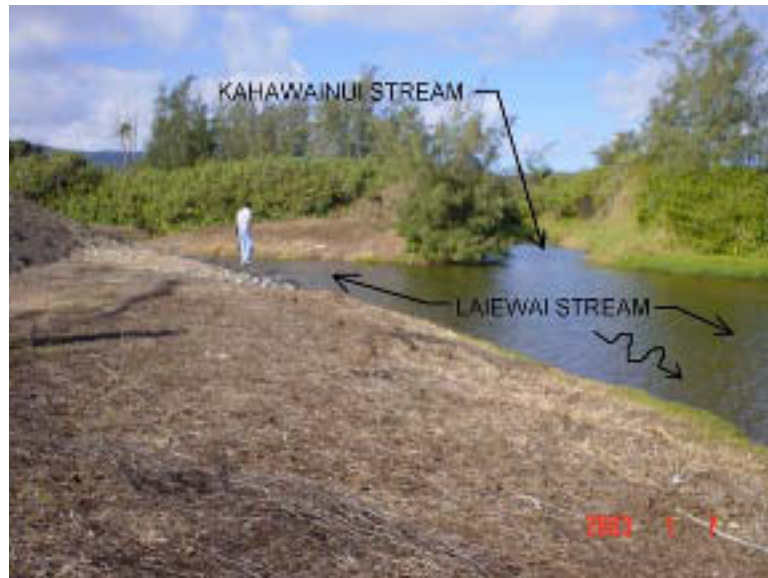
j. Levee A Sta. 4+80, Overview of Kahawainui and Laiewai Stream confluence.

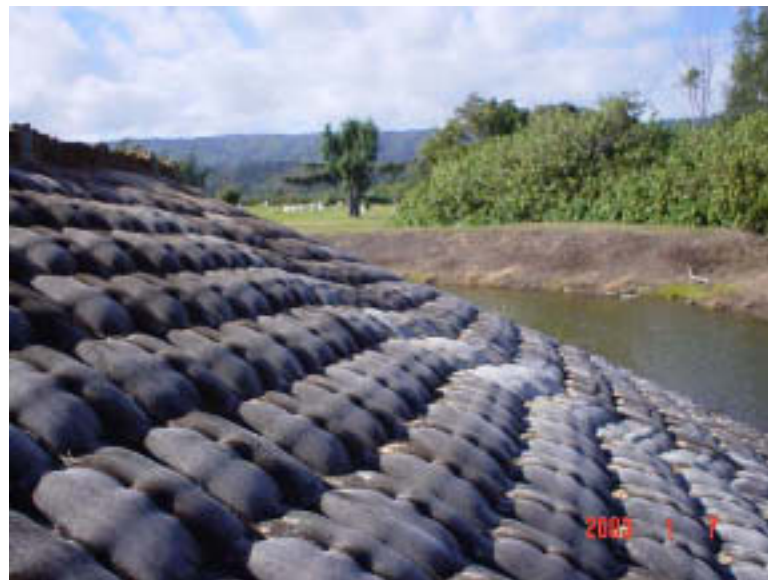
k. Levee A Sta. 5+00, RB, Overview looking mauka.

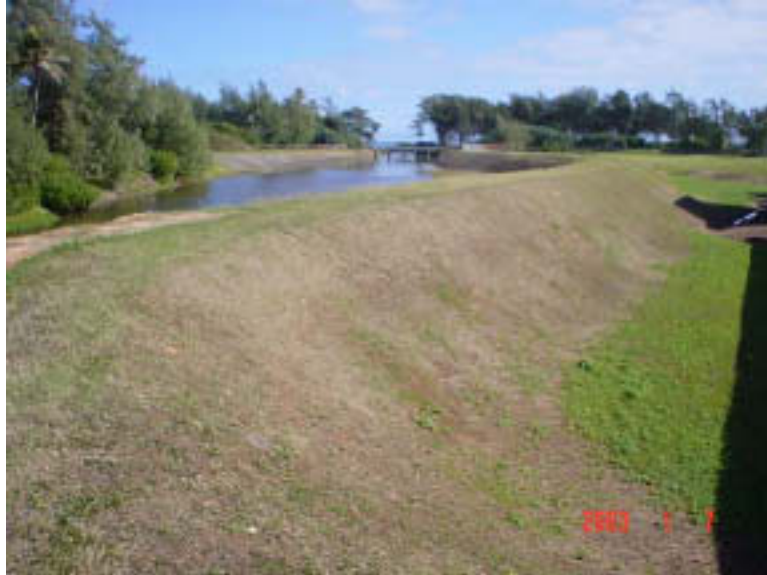
l. Levee A Sta. 5+50, Overview looking at Kamehameha Highway in makai direction.

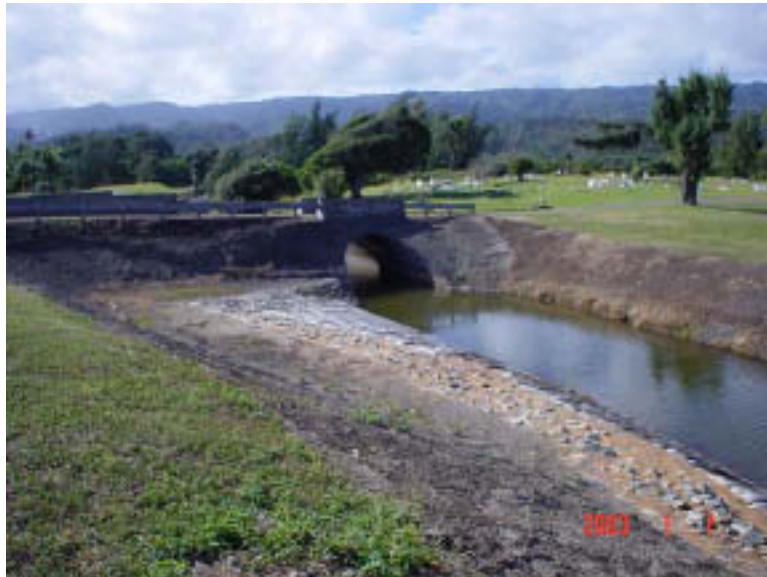
m. Levee A Sta. 6+00, Overview looking upstream of flow at Waihinepee Street bridge.

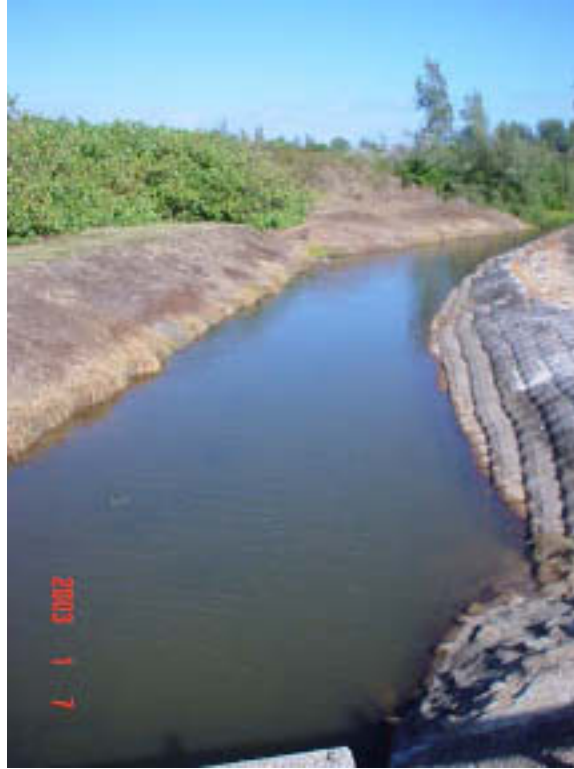
n. End Levee A Sta. 6+63, Overview taken from Waihinepee Street bridge looking downstream of flow.

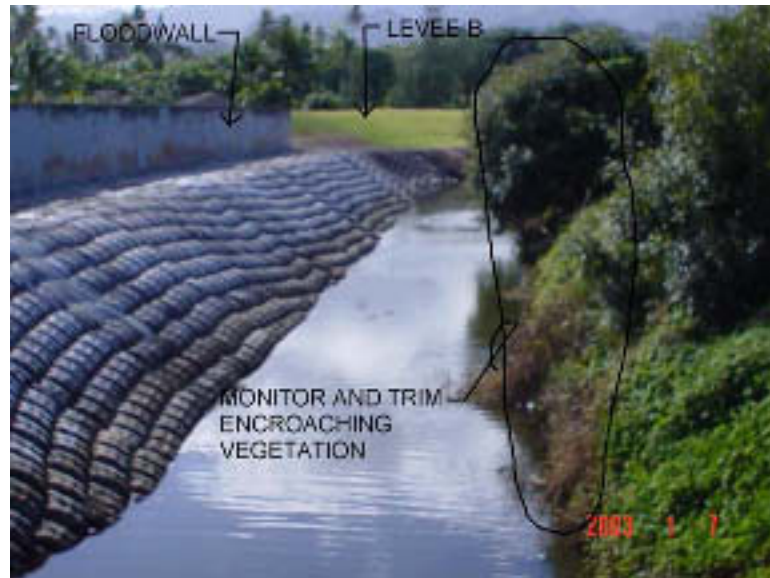
o. End Levee A Sta. 6+63, LB, Monitor and trim encroaching vegetation. Overview looking upstream of flow.

| Location | Station | Defects |
|---|---|--|
| Opposite Levee A, LB | 6+63 | Monitor and trim encroaching vegetation. |

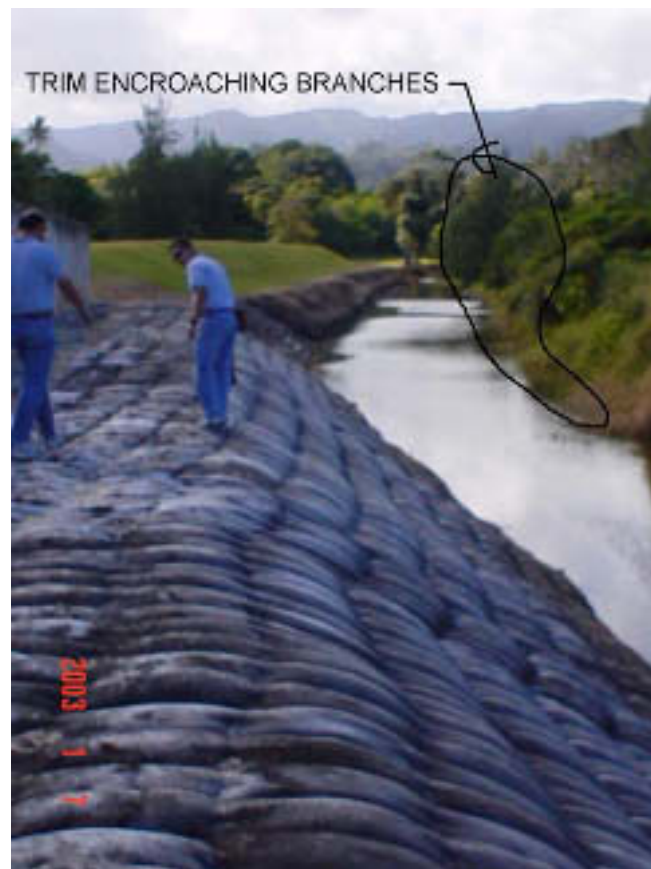
p. Levee B Sta. 0+50, LB, Trim encroaching branches (typical).

| Location | Station | Defects |
|---|---|--|
| Opposite Levee B, LB | 0+50 | Trim encroaching vegetation. Typical on LB across levee B. |

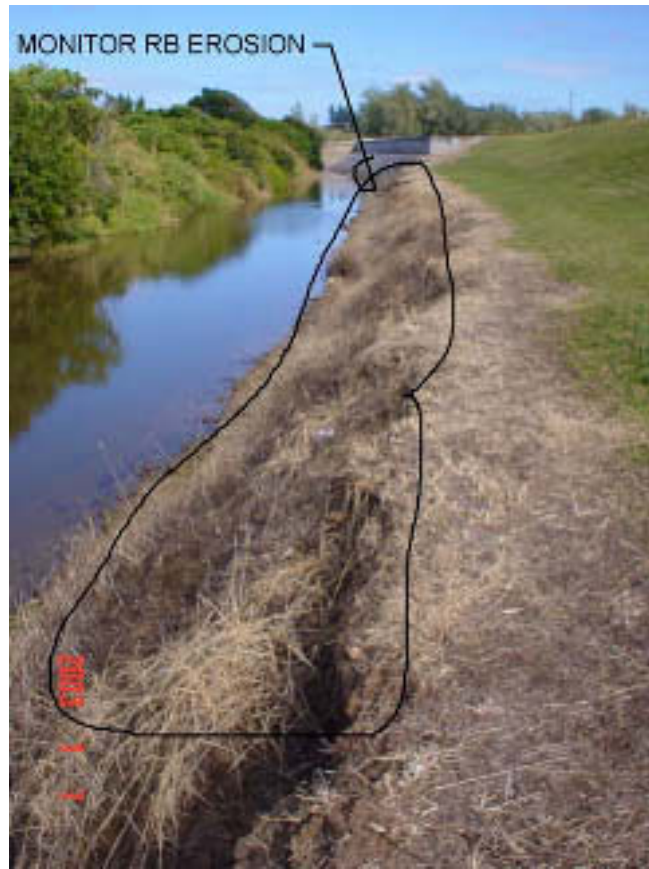
q. Levee B Sta. 3+00, Overview looking downstream of flow towards floodwall.

| Location | Station | Defects |
|---|---|--|
| Levee B, RB | 3+00 | Monitor bank erosion |

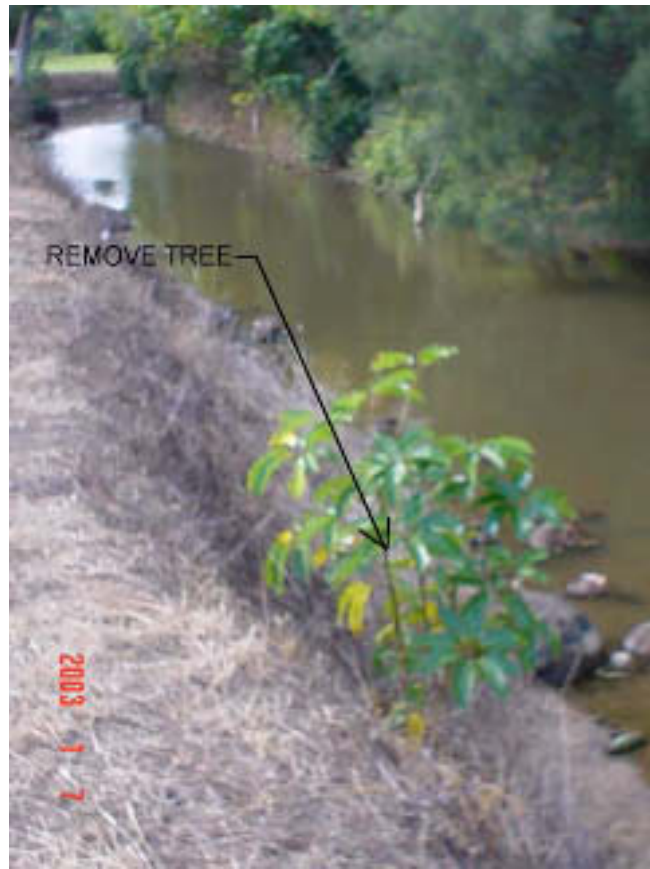
r. Levee B Sta. 3+50, RB, remove tree.

| Location | Station | Defects |
|---|---|--|
| Levee B, RB | 3+50 | Remove tree. |

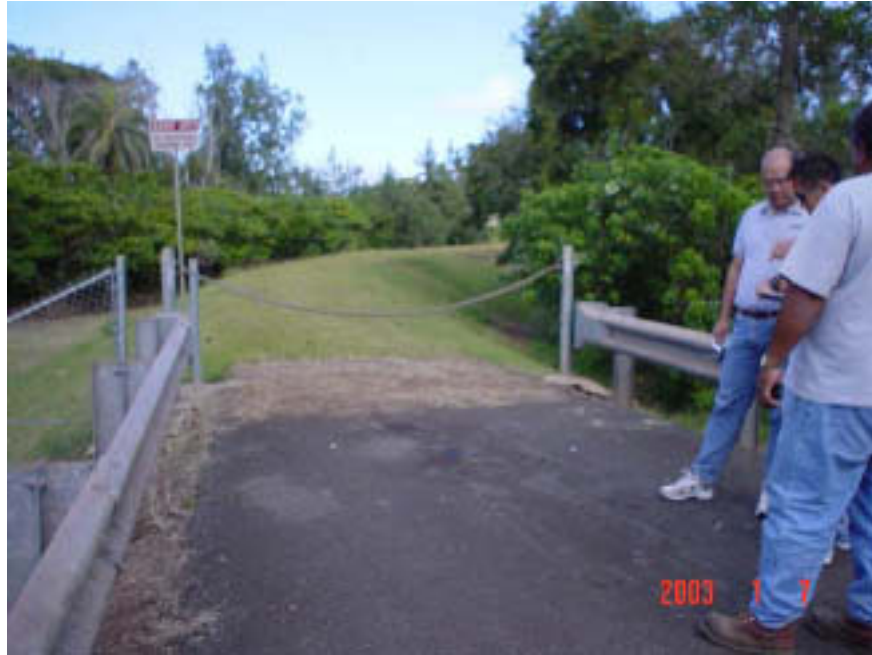
s1. Levee B Sta. 6+60, RB, Overview of maintenance access to levee B looking downstream of flow.

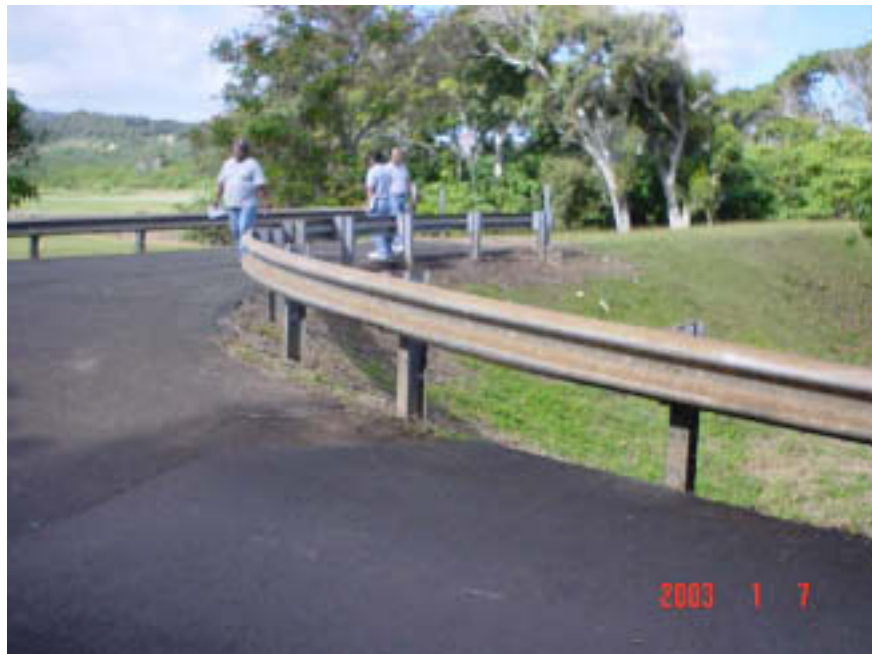
s2. End Levee B Sta. 7+59, RB, Overview of maintenance access to levee B.

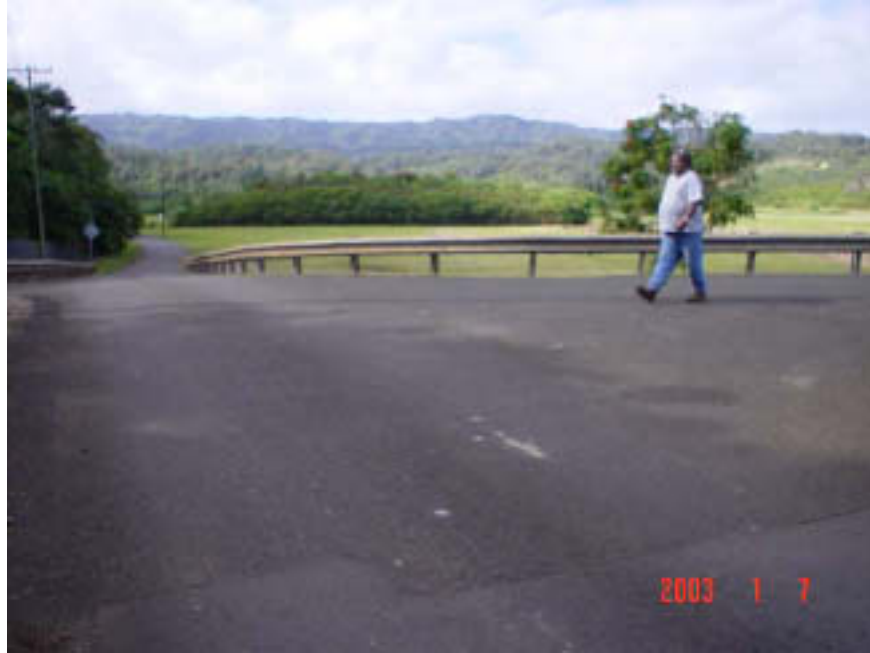
s3. End Levee B Sta. 7+59, Overview of Poohaili Street maintenance access to levee B looking mauka; turn right in picture to Levee B. End of project.
